APPENDIX 1
Foundation Treatment for Little Blue Run Dam

FOUNDATION TREATMENT FOR LITTLE BLUE RUN DAM

By Gerald R. Thiers¹, L. W. Lobdell² and B. M. Mihalcin³

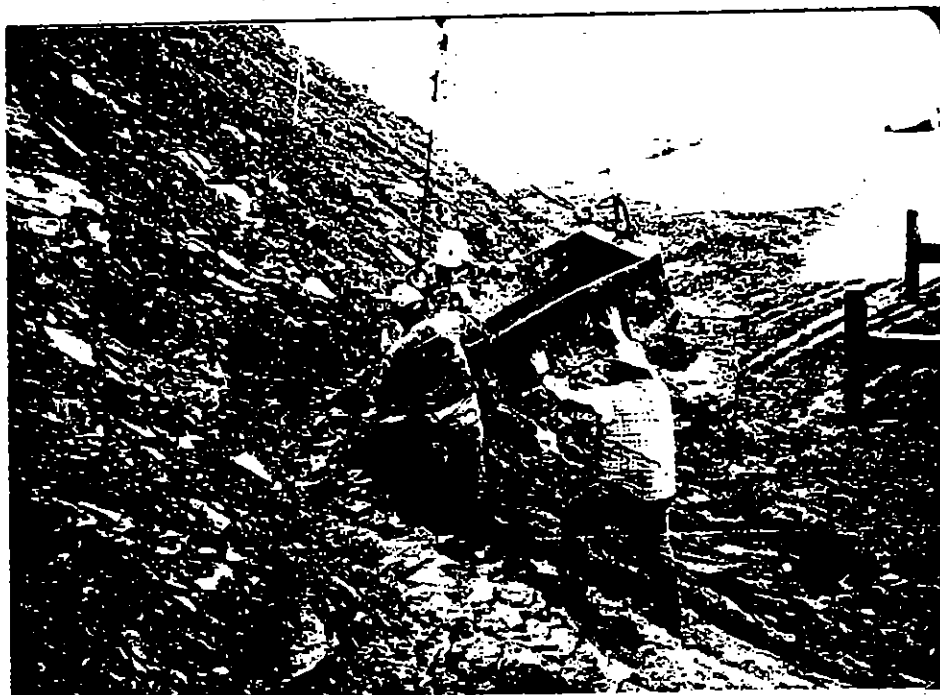
FIGURE 11 - SEALING JOINTS WITH SLUSH GROUT

"Dental concrete," a four-sack, sand-cement mixture supplied by a local redi-mix distributor and brought to the site in mixer trucks, (Fig. 10), was used to fill large open joints, to seal jointed rock and erodible seams (coal and underclay) (Fig. 10), and to fill overhangs in which compaction of fill would be difficult. (Filling of overhangs was resorted to only when the overhang could not be eliminated by trimming.) The mixture was transported from the mixer truck to the rock face in the truck chute (Fig. 10) or a shallow pan suspended from a mobile crane. Laborers spread the material on the rock surface, smoothing it with the backs of their shovels. Where a rock surface was highly jointed, slush grout, formed by diluting the dental mixture to the consistency of milkshake, was poured over the surface from the carrying pan (Fig. 11). Laborers spread the slush grout with shovels and brooms, developing a coating nominally one-eighth to one-quarter inch thick.

Blanket grouting beneath the core (Figs. 10 and 11) followed the pattern shown in Fig. 12. The primary exploratory holes in a given area were drilled first (50-foot centers along the centerline of the core-contact area), and packer tested to check on the local depth of Zone A, ($k > 10^{-4}$ centimeters/second), the zone to be blanket grouted. (In general, the depth of Zone A was 20 to 40 feet.) Because of the critical nature of the core zone, pressures were limited to a maximum of 0.75 pounds per square inch per foot of depth, and survey points were initially monitored to detect any tendency for foundation uplift. The exploratory holes were extended to a depth of approximately 80 feet to be certain no important permeable zones were missed. Pressure grouting was then carried out below Zone A in each exploratory hole. (Zone A was left ungrouted in these holes until after additional testing as described below.) (Pressures were limited as noted above for packer testing.) When the grout take in a given hole exceeded 0.15 bags per lineal foot of grouted hole, the adjacent secondary exploratory holes were also drilled, tested, and grouted (grouting in Zone B only). However, grout takes in the lower portions of the primary exploratory holes were generally less than 0.15 bags per foot, so that few secondary and tertiary exploratory holes were drilled.
